Protection Application Issues Near Strong Grounding Paths

Russell W. Patterson
Tennessee Valley Authority

Elmo Price
Substation Automation and Protection Division
ABB Inc.

Presented to the
29th Annual
Western Protective Relaying Conference
October 22-24, 2002

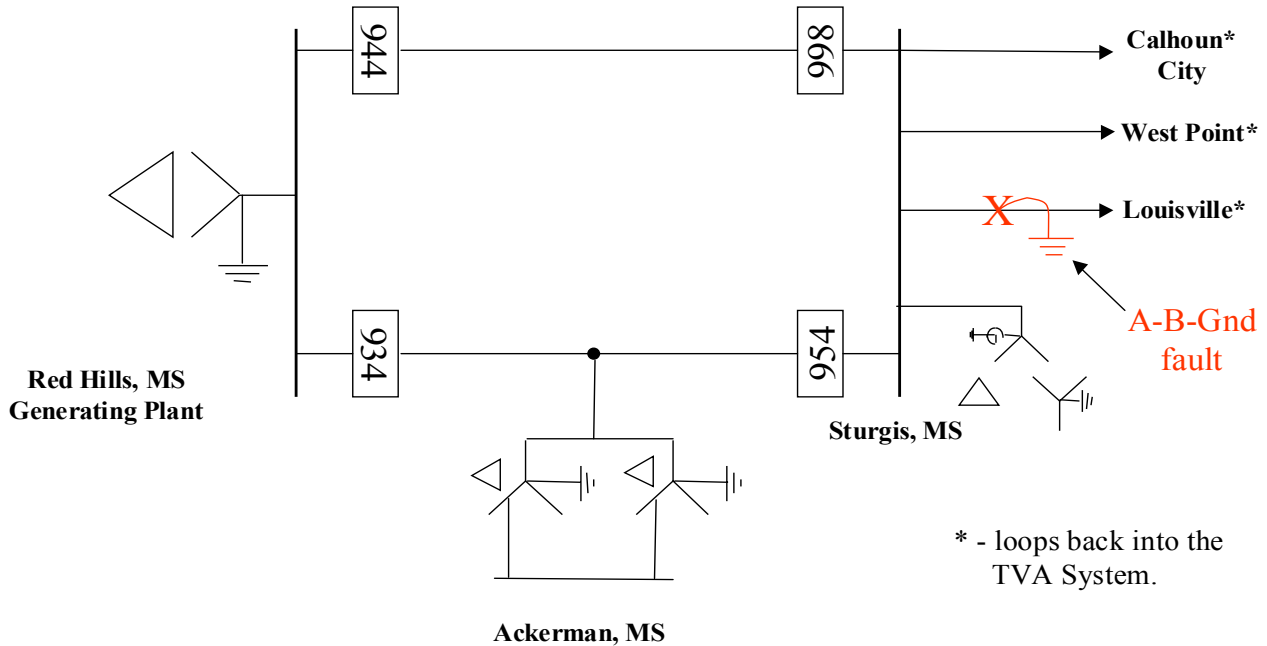
Figure 3. System Configuration with A-B-Ground Fault.

This event was precipitated by a double-phase-to-ground fault on one of the adjacent lines out of Sturgis as shown in figure 3. When this fault occurred, the Red Hills generator was off-line so that only zero sequence current could flow from the Red Hills lines into the Sturgis bus. A-set protection for both lines incorrectly tripped. B-set correctly restrained from operation. Digital fault records were collected from both sets of protection and analyzed. Analog and digital quantities recorded by both relays are shown in Figures 4 to 8.

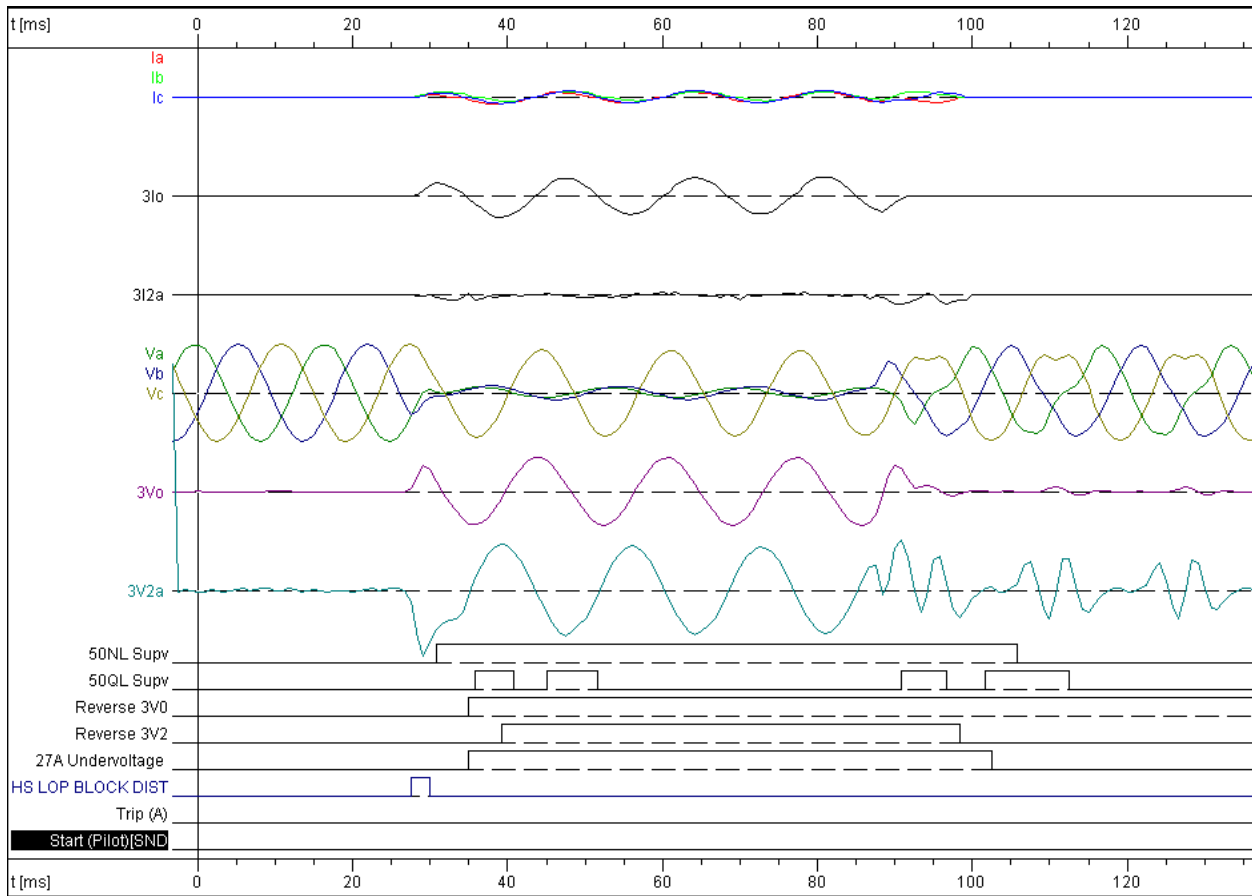
Figure 4. Current, Voltage and Digital Quantities in 998 B-set Relays During Incident 1.

1. The data of Figures 4 and 5 show that the currents I_a , I_b and I_c are in phase. From this it can be inferred that the forward (looking into line # 1 from Sturgis) system zero sequence equivalent impedance is much smaller than the forward positive and negative equivalent impedance. The sequence network of Figure 2 shows the grounding effect of the large wye-delta generator step-up transformer and supports these results.

2. The data of Figures 4 and 8 show no appreciable negative sequence current (Figure 4 . . . 3I_{2a}, Figure 8 . . . I₂) flowing to the fault through the relay. Note that this is consistent with observation #1. The sequence network also readily reveals this. With the switch SW open to show that the generator is out of service, it is observed that there is no positive or negative sequence current source to the relay. The small amount of measured negative sequence current may possibly be explained as motor contribution from Ackerman or possibly some small impedance unbalance or mutual on the parallel lines from Red Hills. It is, however, inconsequential. There is

negative sequence voltage (Figure 4 . . . 3V2a, Figures 7 and 8). This indicates that negative sequence current is flowing to the fault, but not through the relay.

1. The reverse directional zero sequence and negative sequence units of B-set relay (Figure 4 - Reverse 3V0 and Reverse 3V2) operated agreeing with the correct fault direction.

2. The forward directional negative sequence unit of A-set relay (Figure 8 – 32QF) operated for the reverse fault.
3. On the B-set relay (Figure 4) the low-set ground (3I0) instantaneous overcurrent unit (50NL) operated while the low-set negative sequence (3I2) instantaneous unit (50QL) operated on and off indicating it is very close to pickup (200 A primary). This is in agreement with the analog data where I_2 rises above and falls below 67 A.

4. On the B-set relay (Figure 4) there is also a low phase voltage (27 A Undervoltage). The loss-of-potential block function (HS LOP BLOCK DIST) momentarily operates, but does not sustain. The event ends without tripping.

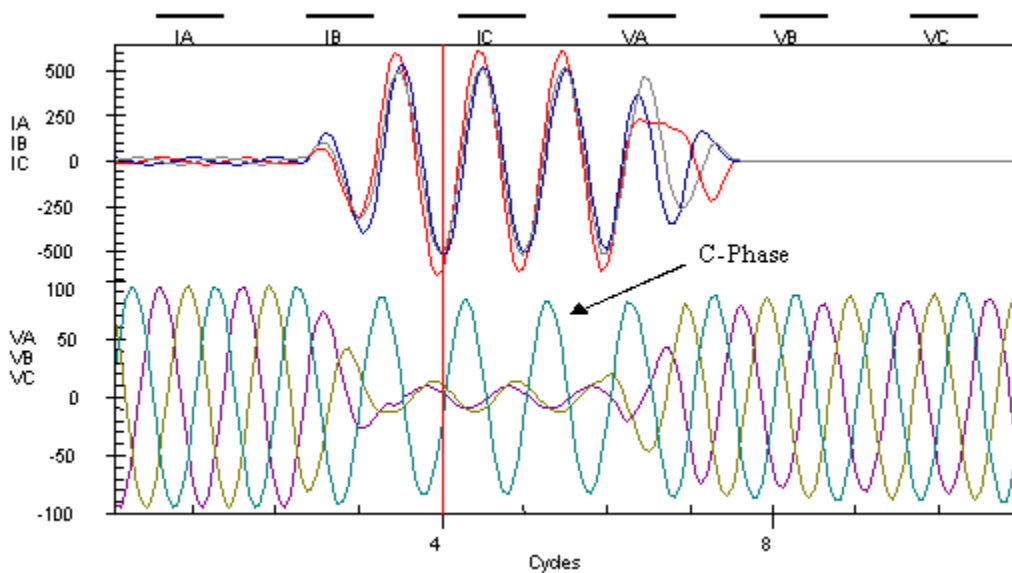
Figure 5. Phase Currents and Voltages in 998 A-set Relays During Incident 1.

Figures 4 and 5 show the analog quantities for B-set and A-set relays, respectively. Different formats are used because different analysis programs are required for the different relay manufacturers. As expected the phase analog data is nearly identical. Figures 5 and 6 show the primary rms values of the sequence currents and voltages for A-set relays. Some observations with respect to the analog data are:

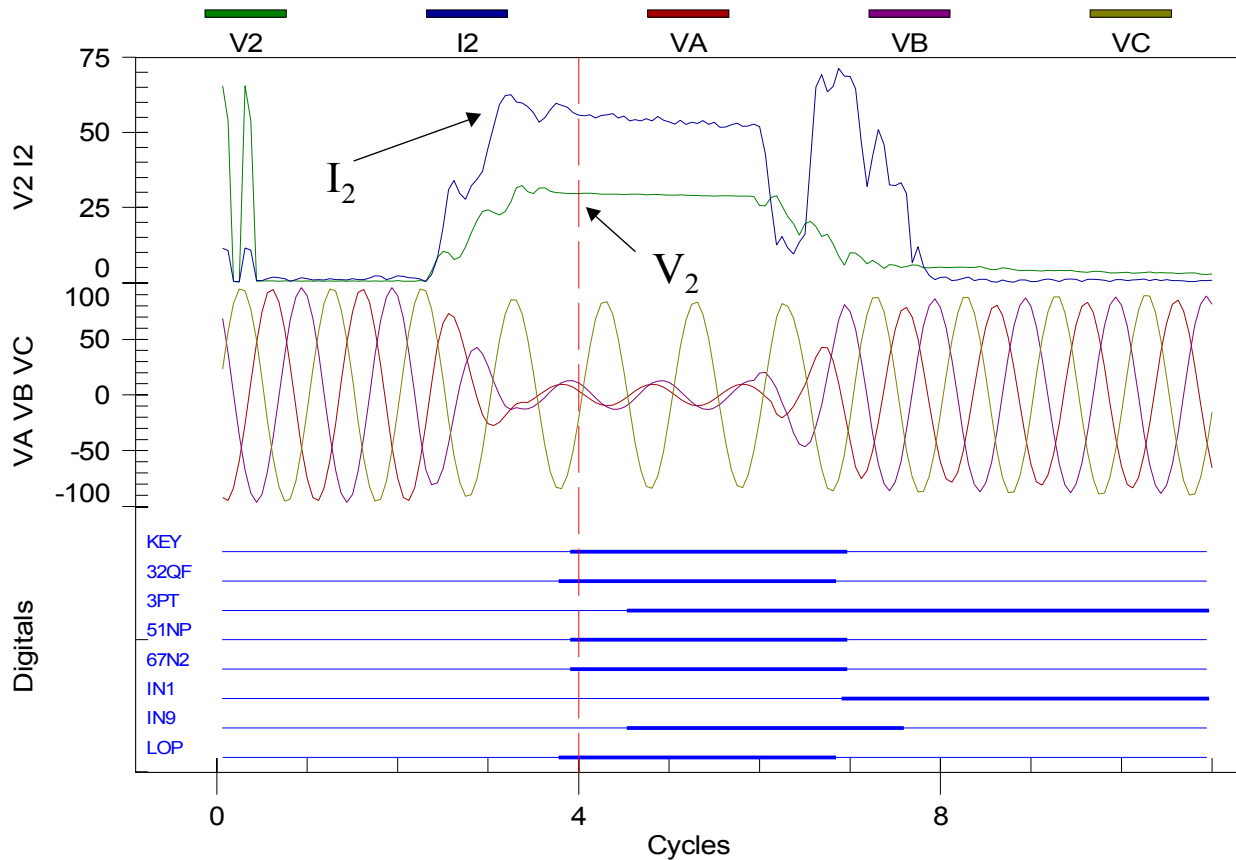
Figure 8. V2 and I2 Magnitudes in 998 and digital traces during Incident 1.

5. On the A-set relay the loss-of potential function (LOP) operated simultaneously with the 32QF. This was followed closely by the simultaneous pickup of the ground time overcurrent element (51NP), the overreaching [forward] directional ground overcurrent (67N2) element, and the pilot KEY signal. One-half cycle later a pilot permissive signal is received on input IN9 and the relay trips.

The cause of the operation is now quickly resolved based on what we have learned in our analysis of the event reports and review of LOP logic. Figure 8 above shows the magnitude of negative sequence current being over 50A primary and that of negative sequence voltage being around 30kV. This value of current would be zero except for the possible motor contribution or unbalance line impedance effects as discussed on page 7. In the logic diagram of Figure 9 the LOP logic looked for negative sequence voltage (59Q) in the absence of negative sequence current (50Q). The 50Q element had a pickup of 67A (actual pickup was 200A as this element operates on $3I_2$, but for purposes of comparison with Figure 8 the pickup will be shown in I_2 amps). The 59Q element had a pickup of 15kV, and it operates on V_2 . From Figure 8 it can be seen that the V_2 present is well above the 59Q setting and the I_2 present is below the 50Q setting. In this case LOP was asserted. See Appendix A for background discussion on these settings.

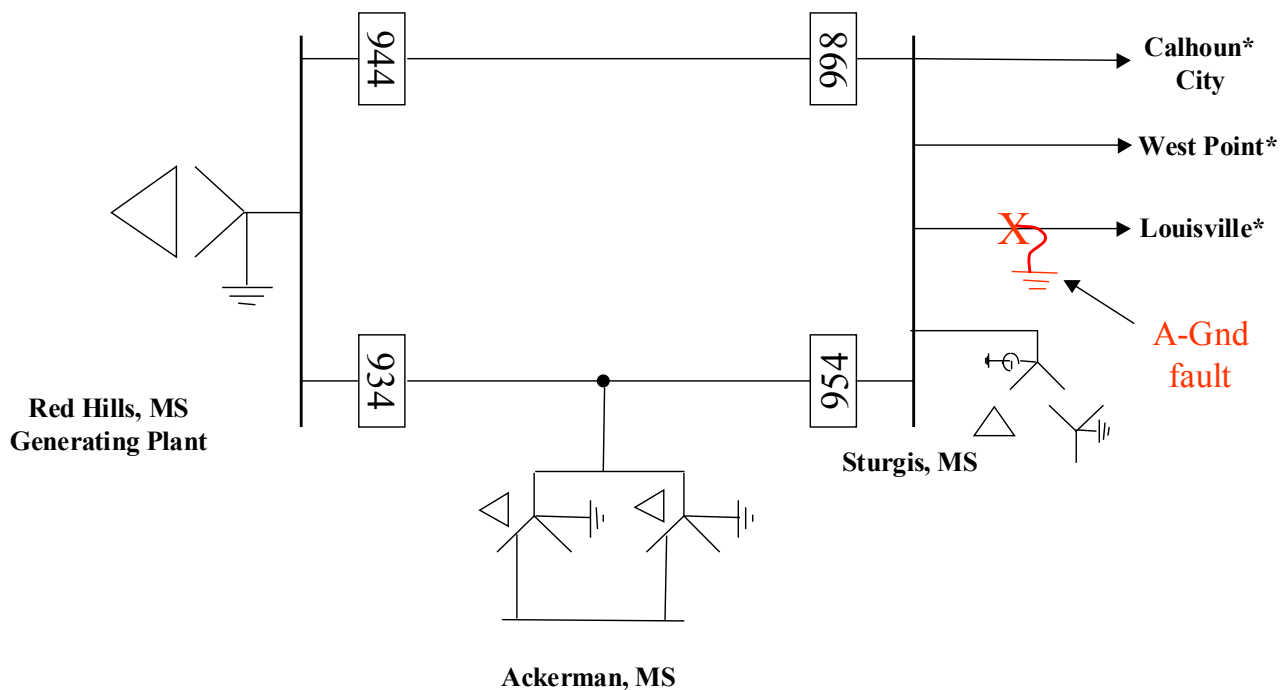
Figure 10. System Configuration with A-Ground Fault.

This incident is similar to the one previously described except that the fault is an A-Ground fault this time and the zero sequence current from Red Hills is less. The system configuration is shown in Figure 10 and the related fault recordings are shown in Figures 11 and 12.

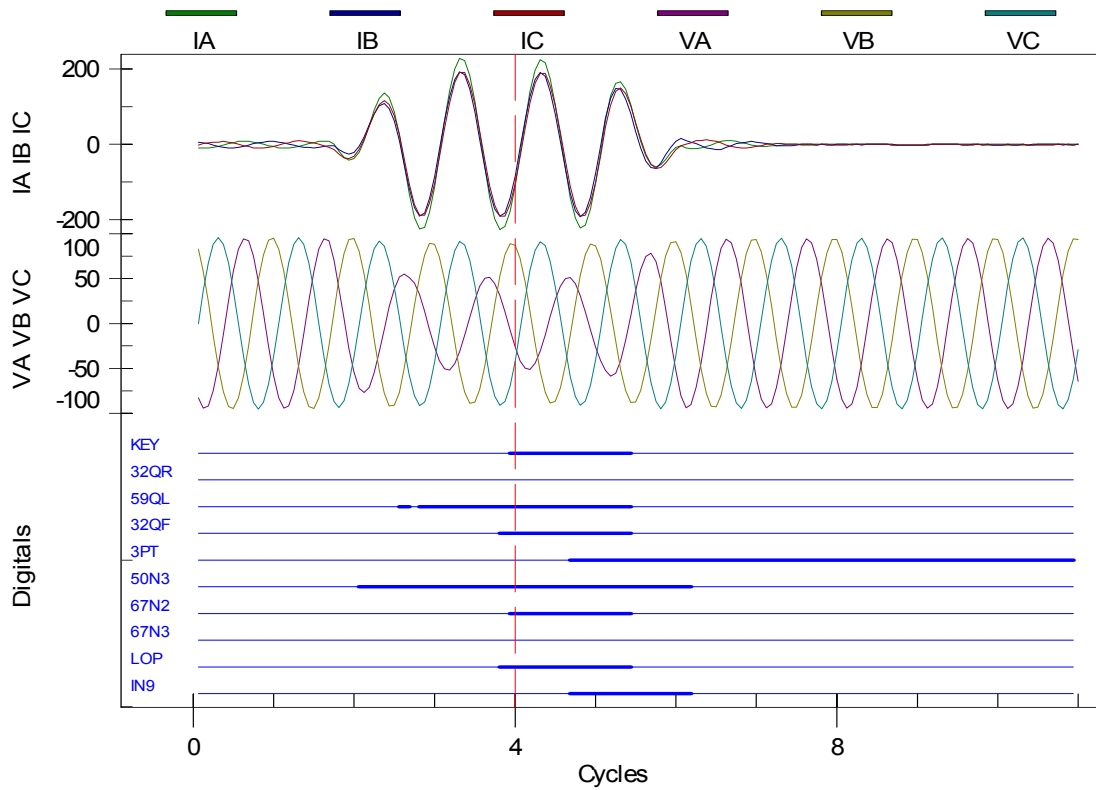
Figure 11. Phase Currents and Voltages with Digital Traces in 998 A-set Relay

For the A-set relay note that when the LOP logic asserts the relay forces directional elements forward as before. In this case, with a POTT scheme, this allowed a pilot trip to occur because the reverse looking residual overcurrent (67N3, that blocks the sending of permission) could not assert even though the residual current present exceeded its 50N3 pickup. It could not assert because its directional supervisor (32QR) is a reverse directional and LOP has forced all directional decisions forward.

The correct logic is similar to that of Figure 3 except it utilizes zero sequence, 50N and 59N. Until the relays could be upgraded to a newer version of firmware with adequate LOP logic the relay was set so a LOP condition would not block distance element operation or force overcurrent directional decisions forward. The logic behind this was that ground faults out of Sturgis were much more likely than a blown fuse.

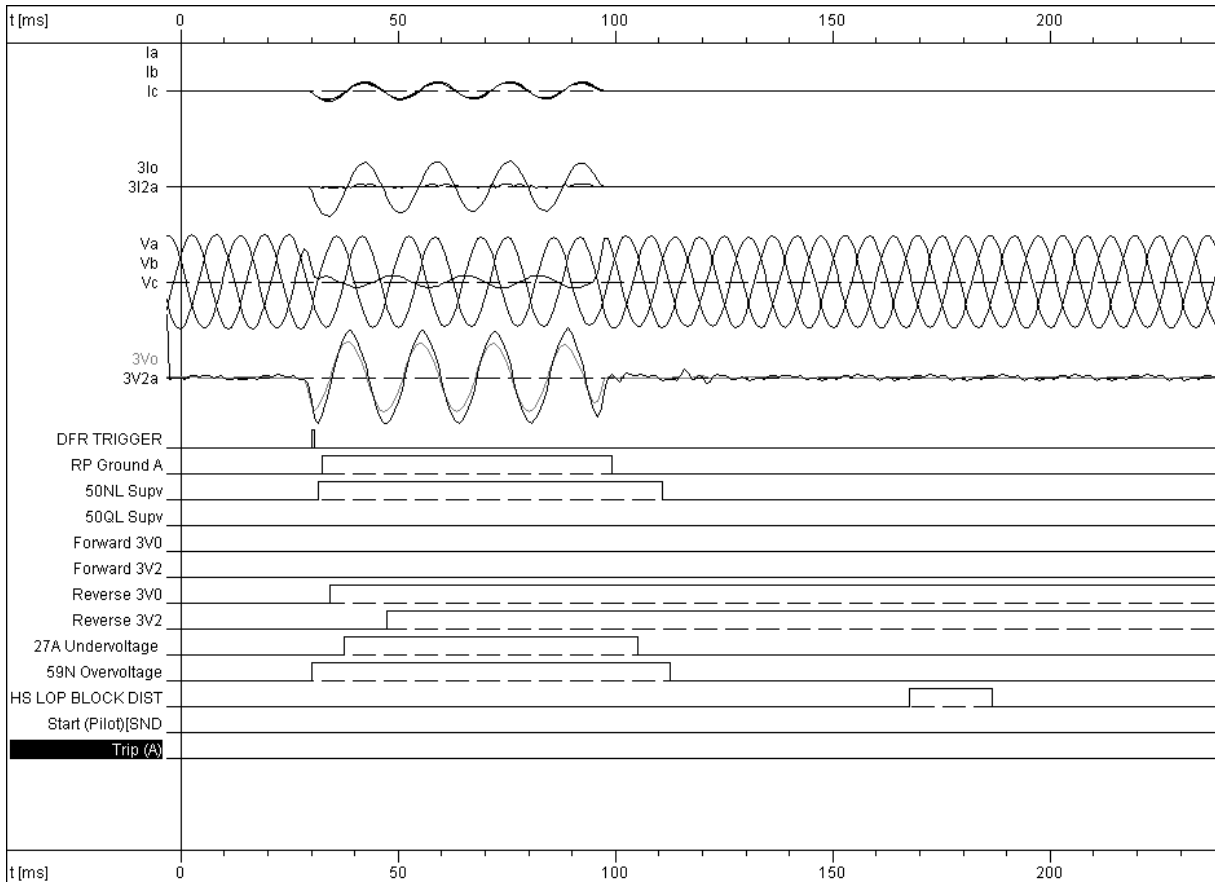
Figure 12. Phase Currents and Voltages with Digital Traces in 998 B-set Relay

The B-set relays at Sturgis correctly restrained from tripping and also provided useful fault data for this case. Analog and digital data are provided in Figure 12.
