Protection Application Issues Near Strong Grounding Paths

Russell W. Patterson
Tennessee Valley Authority

Elmo Price
Substation Automation and Protection Division
ABB Inc.

Presented to the
29th Annual
Western Protective Relaying Conference
October 22-24, 2002

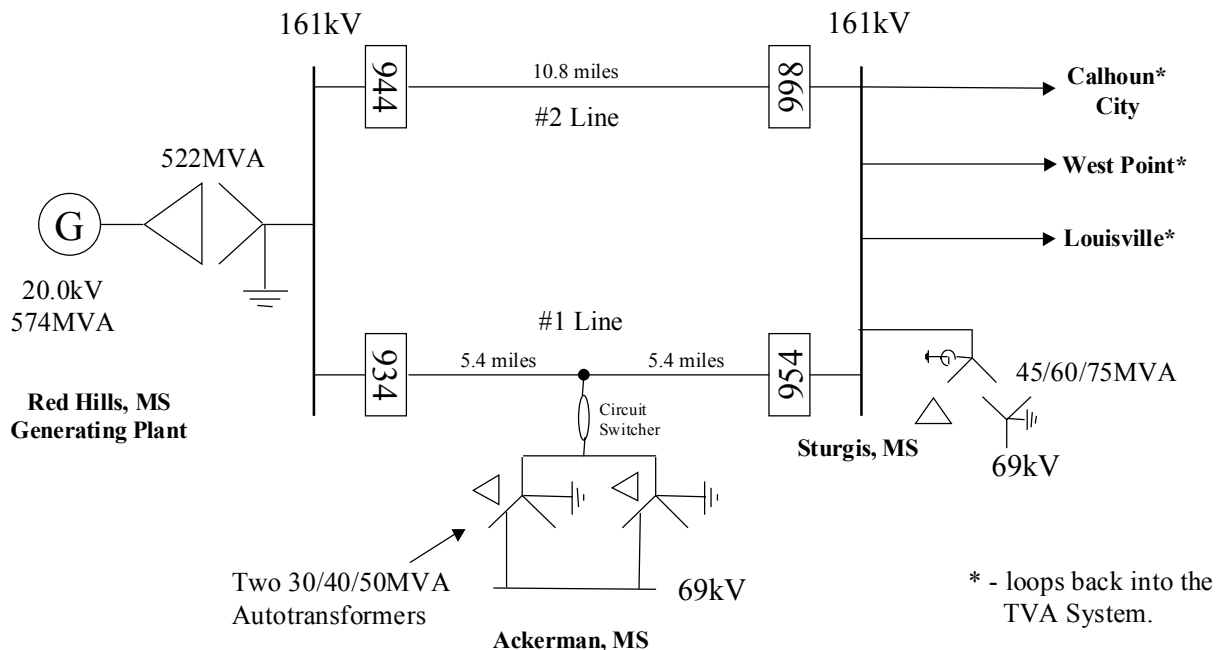
Figure 1. System Single Line

The single line diagram below shows the general arrangement of the system in the Sturgis, Mississippi area. The Red Hills generating plant is connected to the TVA system through two 161kV lines from Sturgis. One of the lines is tapped in the middle with two autotransformers at Ackerman. Also, there is no interconnection to generation (positive sequence source) from Ackerman 69 kV. There are, however, motors at Ackerman 69 kV that have a small transient contribution to faults on the 161 kV system.

The tapped ground path at Ackerman will affect the measured ground impedance reaches at breakers 934 and 954 (see figure 1). This should be considered when setting under and overreaching impedance units. This will be particularly important if a transformer is removed from service and affects the ground path impedance.

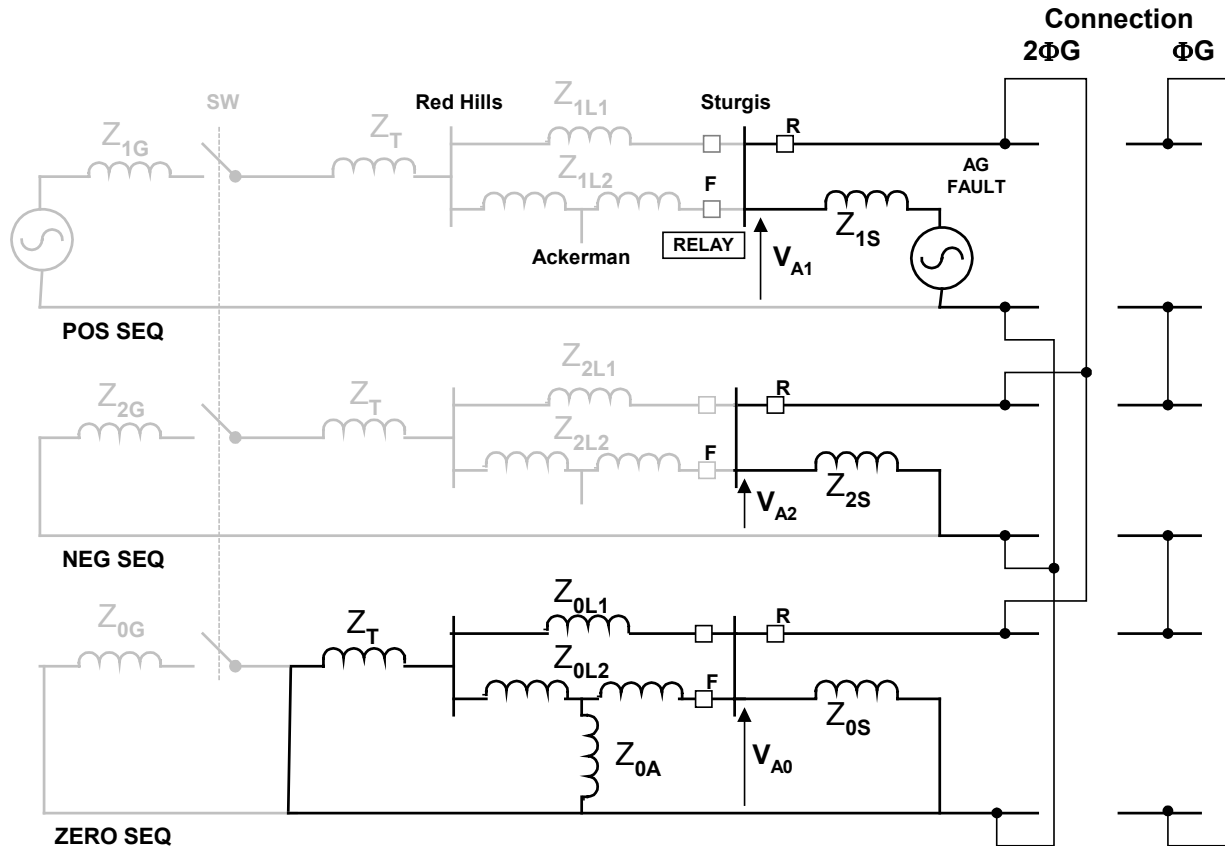
Figure 2. System Sequence Network Connection for Single and Two Phase-to-ground Faults

Figure 2 is the symmetrical component sequence network connection model for the system of Figure 1 with a reverse two phase-to-ground fault connection. It also shows the single phase-to-ground connection. It is provided to better understand the system. The gray area is the part of the circuit where no positive or negative sequence current flows because of the generator (positive sequence source) being disconnected from the system through the open switch SW. As can be clearly seen the positive sequence system source at Sturgis has a [ground] path through the Ackerman (Z_{0A}) and Red Hills (Z_T) transformers that allows zero sequence current to flow in the Red Hills to Sturgis lines

1. The data of Figures 4 and 5 show that the currents I_a , I_b and I_c are in phase. From this it can be inferred that the forward (looking into line # 1 from Sturgis) system zero sequence equivalent impedance is much smaller than the forward positive and negative equivalent impedance. The sequence network of Figure 2 shows the grounding effect of the large wye-delta generator step-up transformer and supports these results.

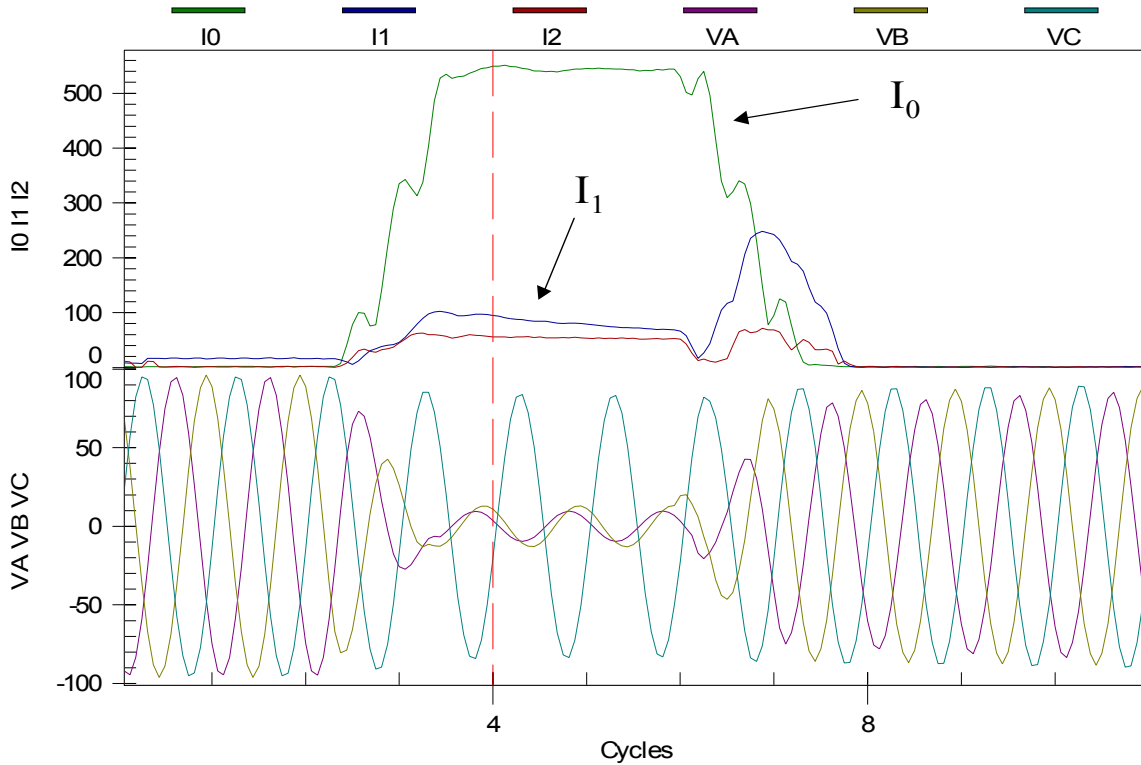
Figure 6. Sequence Currents in 998 A-set Relays During Incident 1.

Note: I_1 and I_0 are plots of the rms quantities computed over the previous cycle of sample data.

Figures 4 and 5 show the analog quantities for B-set and A-set relays, respectively. Different formats are used because different analysis programs are required for the different relay manufacturers. As expected the phase analog data is nearly identical. Figures 5 and 6 show the primary rms values of the sequence currents and voltages for A-set relays. Some observations with respect to the analog data are:

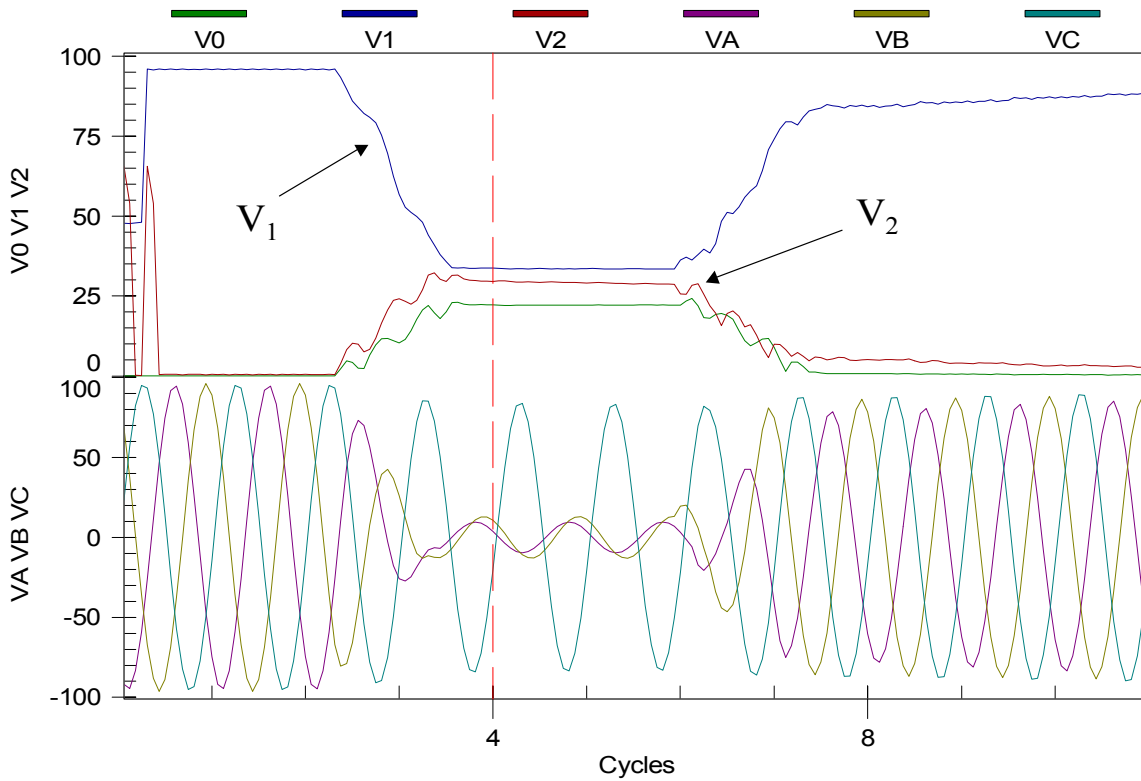
Figure 7. Sequence Voltages at 998 A-set Relay During Incident 1.

Note: V_1 and V_2 are plots of the rms quantities computed over the previous cycle of sample data. The irregular waveform at the beginning of these traces is due to the fact that the sequence quantities are calculated in the oscillograph display program and at the beginning of the shot they have incomplete data to be computed until a full cycle of data is available.

negative sequence voltage (Figure 4 . . . 3V2a, Figures 7 and 8). This indicates that negative sequence current is flowing to the fault, but not through the relay.
